Inspection: Address

Chimney System/Fireplace(s)/Stove(s)

Chimney System

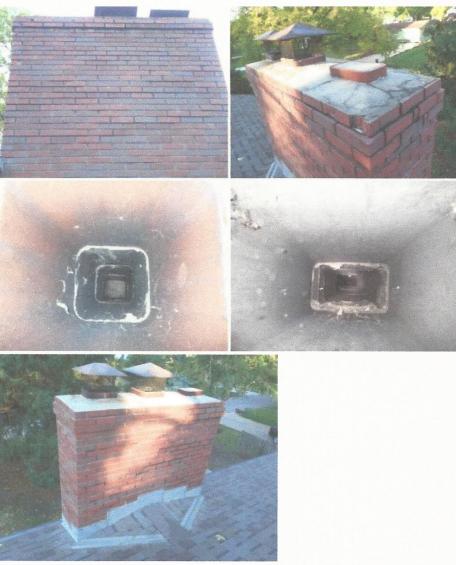
The chimney above the roof line has mortar joints that are darkened from water running down them and moss or fungal growth in them. There are a few bricks spauled off at the top. The reason water is running down the face of the bricks is the concrete crown is inadequate. Inadequate & cracked concrete crown. A proper concrete crown is supposed to be a minimum 2" thick and overhang the edge of the brick by 1" to prevent water from running down the side of the chimney.

The center clay-tile liner has deteriorated mortar joints. I wasn't tall enough to properly look down the right flue for the basement fireplace, but from the fireplace looking up, the smoke shelf and clay-tile liner had creosote buildup.

The basement floors has settled and slopes towards the chimney indicating that the chimney system has possibly settled a little. I don't think the movement is much.

Recommend having a Chimney Safety Institute of America (CSIA) Certified Chimney Sweep conduct a Level 2 inspection of the entire chimney system and repair as deemed necessary.

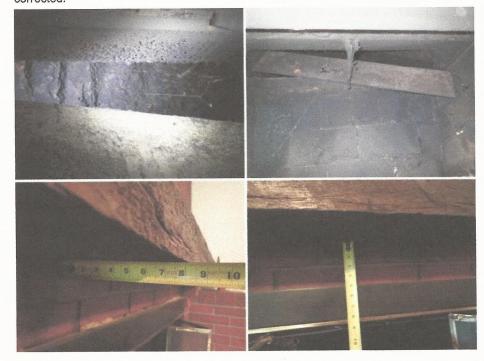
There is creosote buildup in the smoke shelf. The damper is inoperable. The back of the firebox has some loose bricks leaning inward. The wood mantel extends out too far into the room on this wood burning fireplace. This is a fire hazard and needs to be corrected.

See recommendation above.
