Inspection: [REDACTED] Address: [REDACTED]

Deck

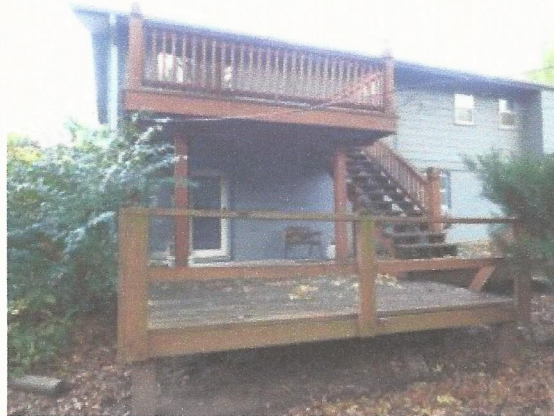
Treated Lumber. This type typically needs to be power washed and weather sealed every 4-6 years depending on how well the stain holds up. Don't forget to do the underside too.

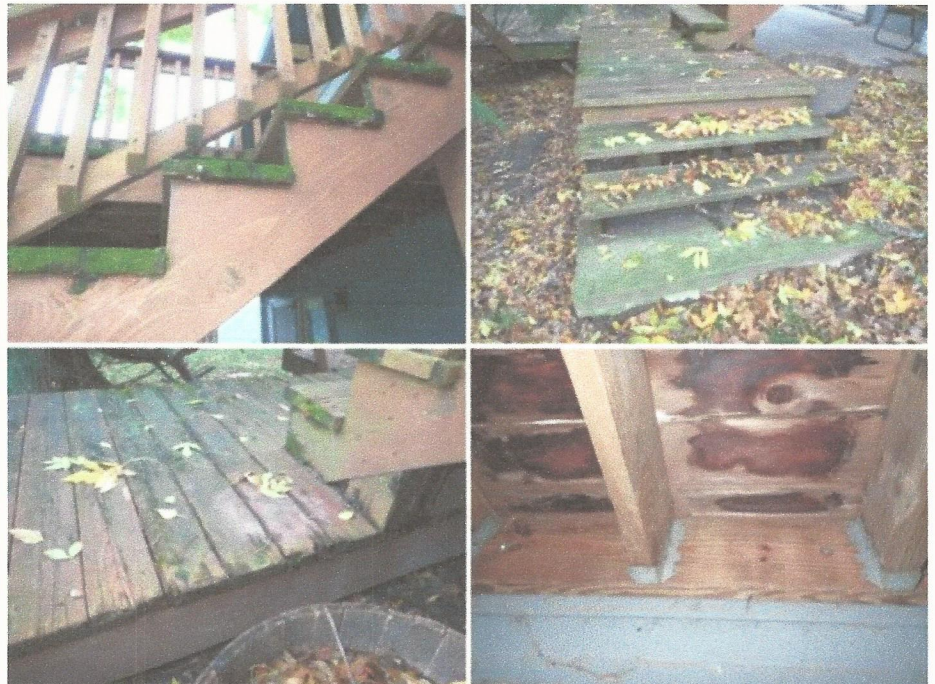
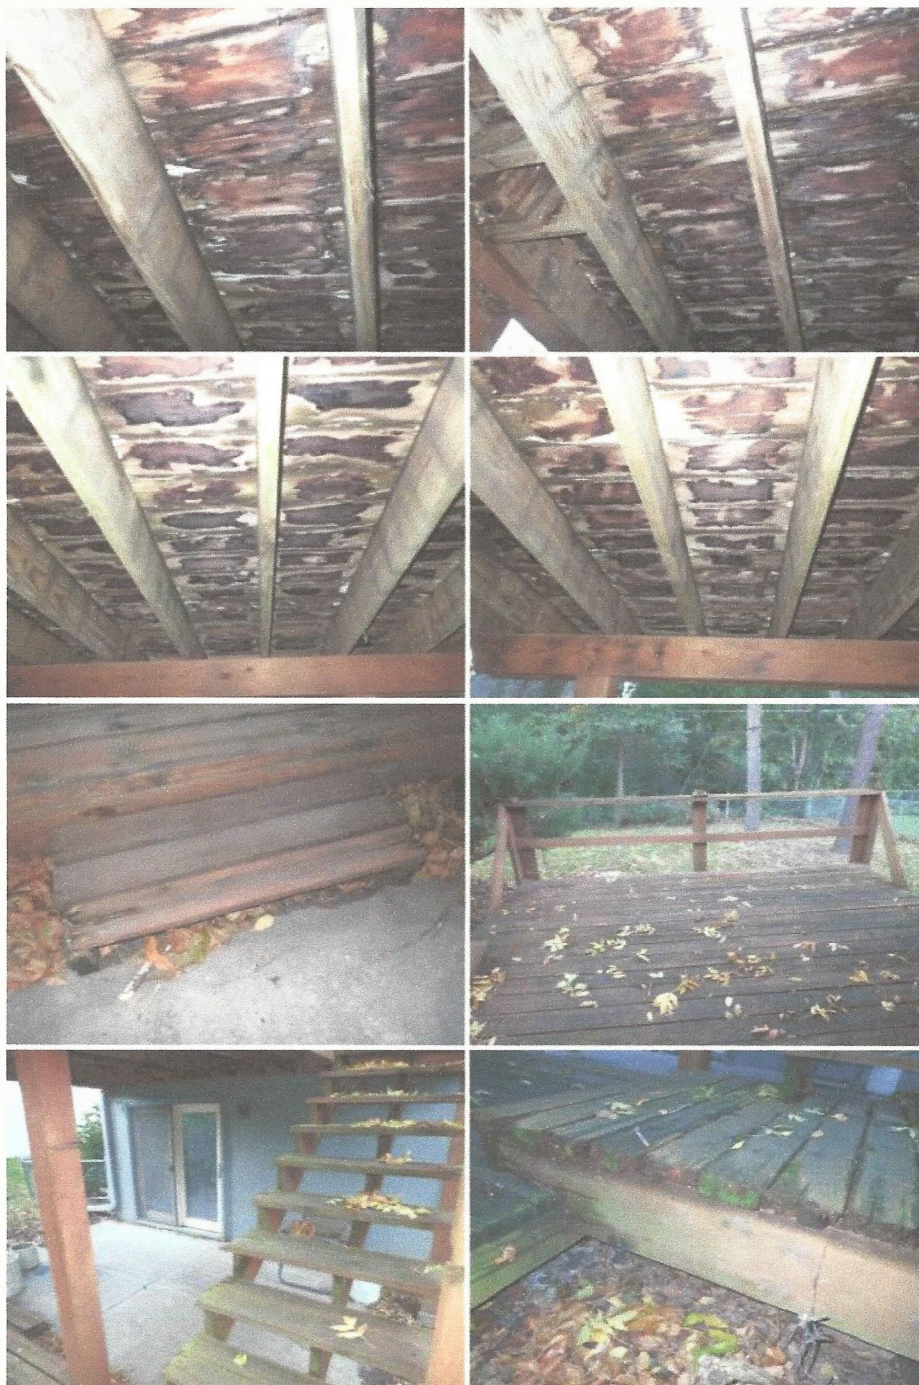
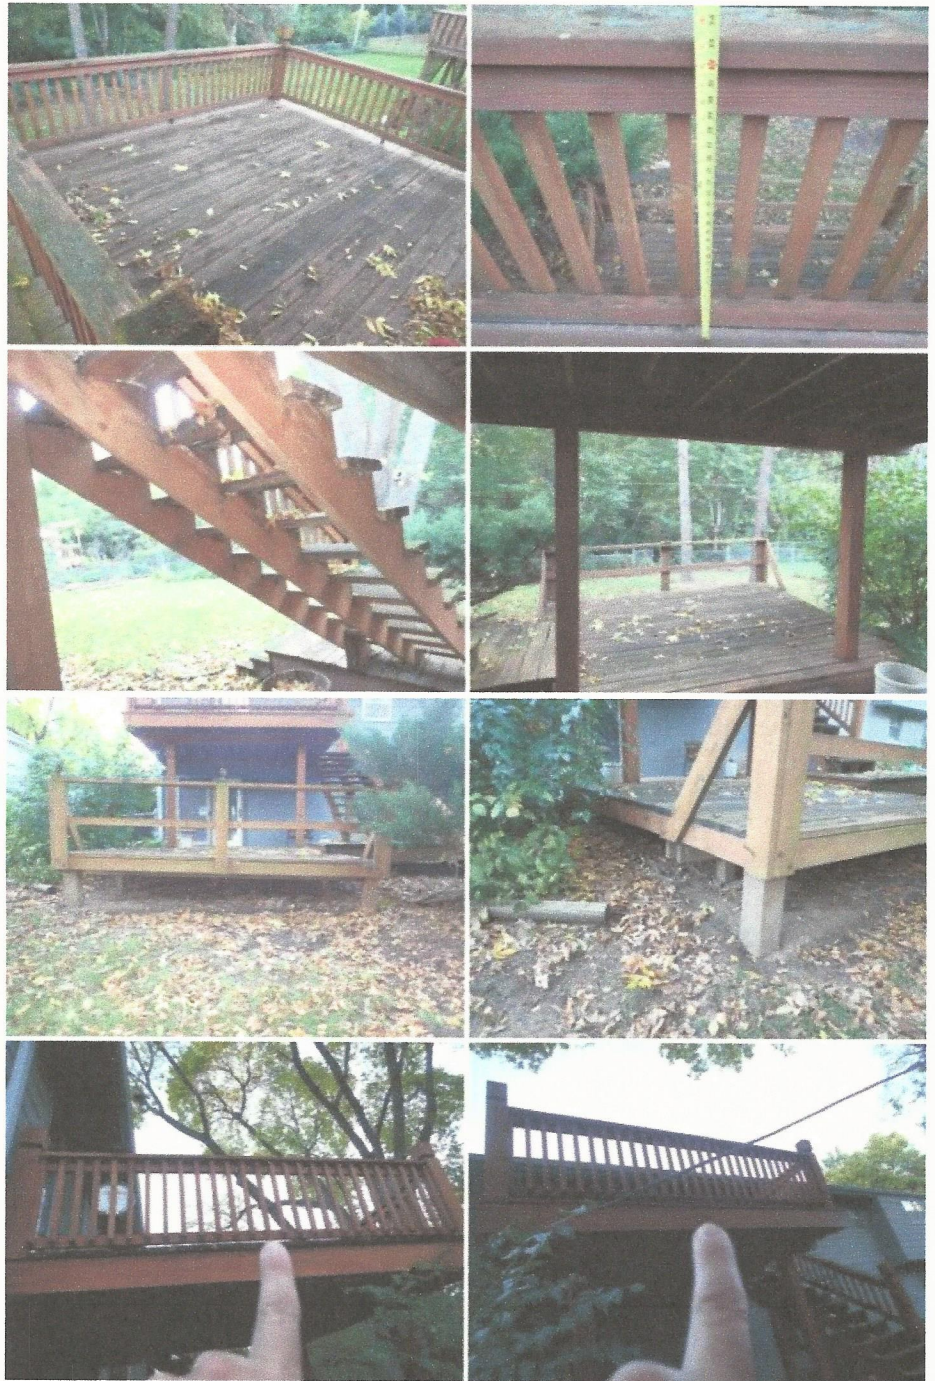
The deck has issues. The upper deck has a bunch of rotted deck boards on the underside and ends. The railing is 33" high instead of 36" with the baluster spacing wider than 4". The railing is loose because the guard posts are starting to rot underneath. The upper deck sways because it does not have diagonal bracing on the posts. The stringers are rotting along with the ends of the stair treads. There is no diagonal bracing on the bottom of the stringers which is why the stairs sway. The stairs are missing a handrail and balusters down 1 entire side making it a fall hazard for little children. The handrail that is present has a rotted and very loose post at the bottom. The landing at the base of the steps is rotting. The lower deck is sitting in soil by the patio. The back left corner of the lower deck has settled making the deck lopsided. I suspect the footings are inadequate under the lower deck. The railing on the lower deck is inadequate. It's not designed to withstand a 200 lb force exerted laterally on it. The kick out flashing is missing on the ledger board. The guard posts are missing in the middle of the railings where I'm pointing to in the last photos.

Recommend having a licensed Contractor review and repair/replace as deemed necessary.
