Inspection: [REDACTED] Address: [REDACTED]

Electrical System

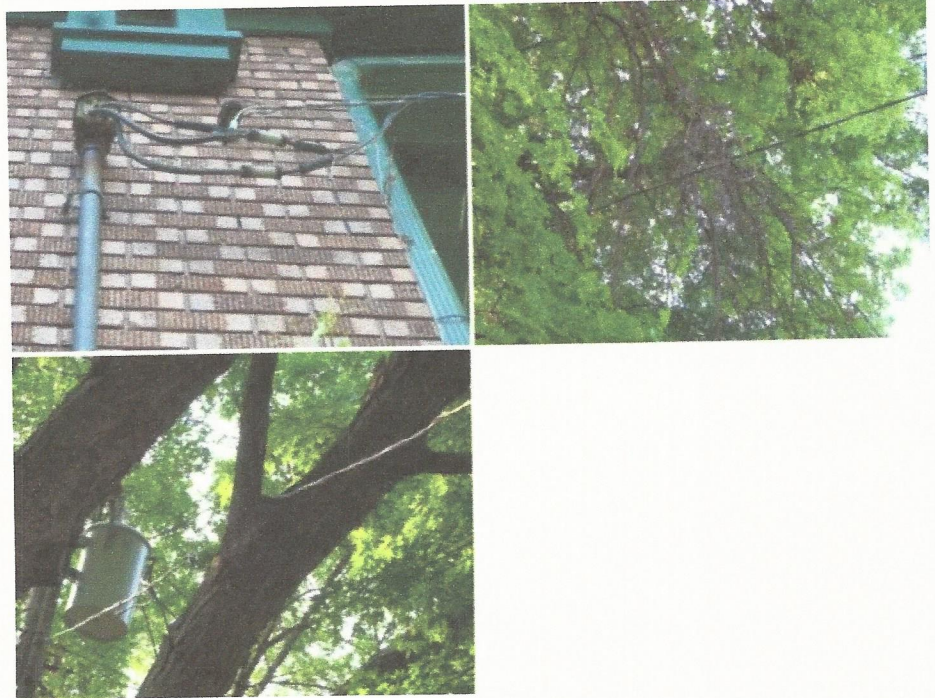
Overhead, the service line is running through the crotch of the Maple tree. Over time, the movement of the tree and/or the wires can cause the sheathing to wear down exposing the bare wires and leading to a fire. There is also a dead branch from the Oak tree touching the line. These need to be corrected.

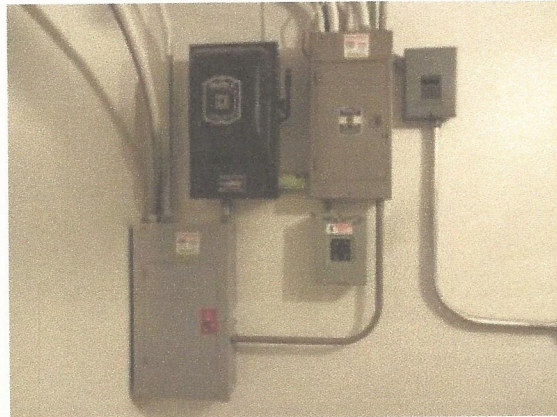
Type: Knife Fuse in the Main panel with a fuse panel that is supposed to be the main, but has been reconfigured improperly.

Condition: The main disconnect panel with the knife fuses have the main lugs at the bottom improperly triple tapped with different sized wires. This is a fire hazard. 1 set of wires runs over to the main fuse panel, another runs directly over to the sub-panel under the main fuse panel, and the 3rd runs below left to the additional sub-panel that has breakers. Both of these sub-panels should have never been installed. The main fuse panel has the main pull fuse down-sized and should be 60 amps. It was either 45's or 30's. I can't remember. Theoretically, when this pull fuse is removed, the power to all of the screw fuses below should no longer have power. The service entrance cable feeding this has been down-sized and has melted. This is a fire hazard. When I removed the pull fuse to the right, this has arced in the past and melted the plastic. This may be a fire-hazard.

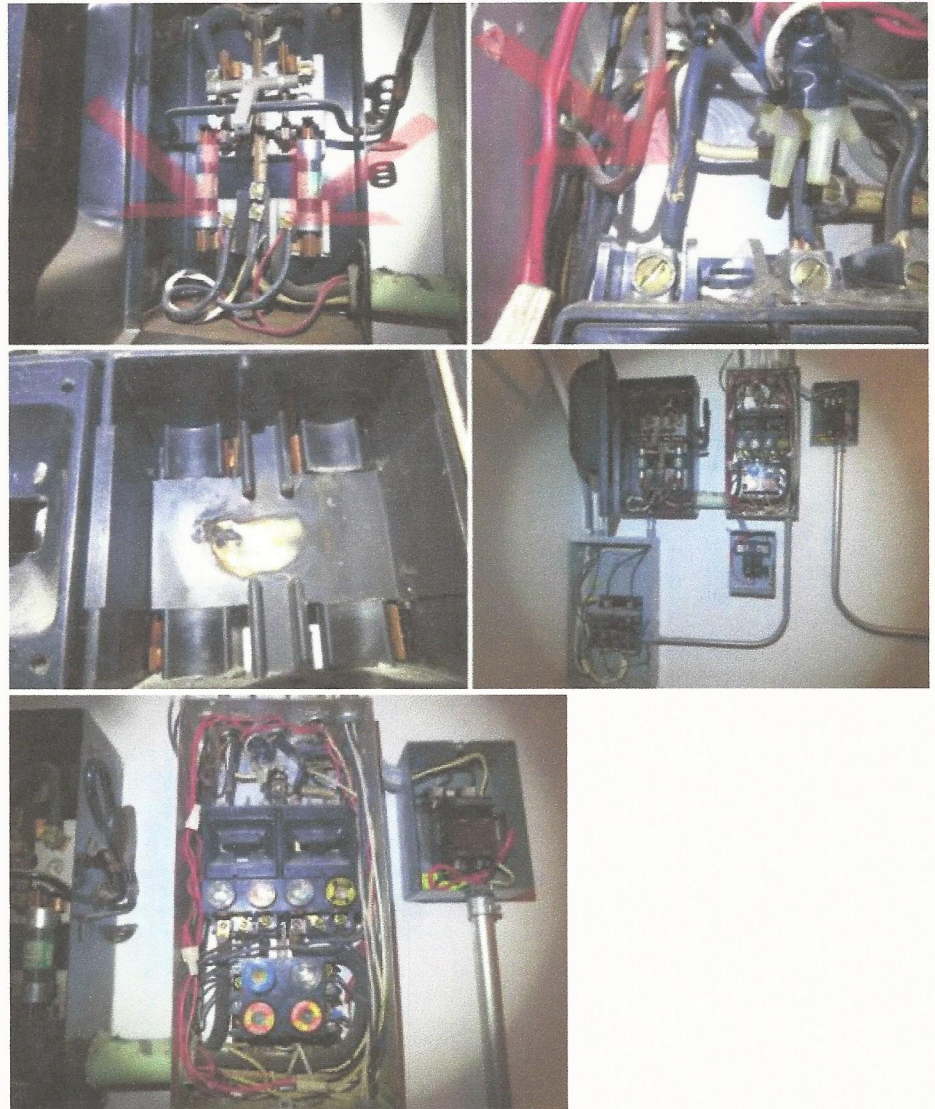
Basement Sub-Panel at the bottom left

The sub-panel to the bottom left has hot & neutral wires sharing the same bar. There never should be any hot (black) wires on the bar.

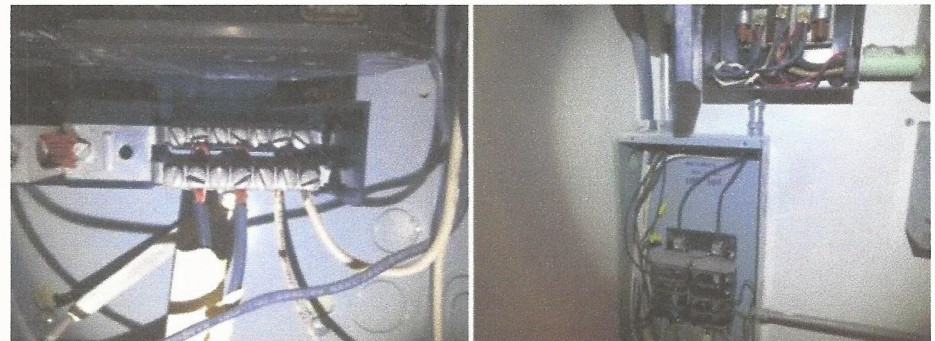
Basement Sub-panel bottom right

This sub-panel should have never been installed. It's triple tapped out of the main disconnect panel.
