Inspection: Address:

Roof Covering

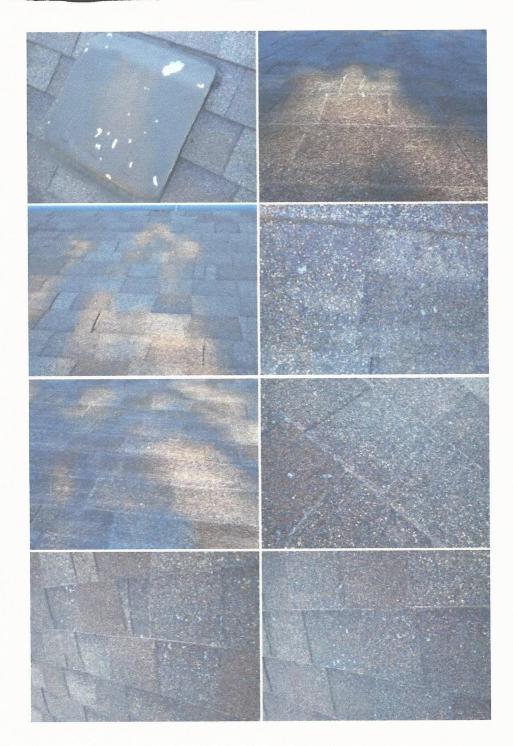
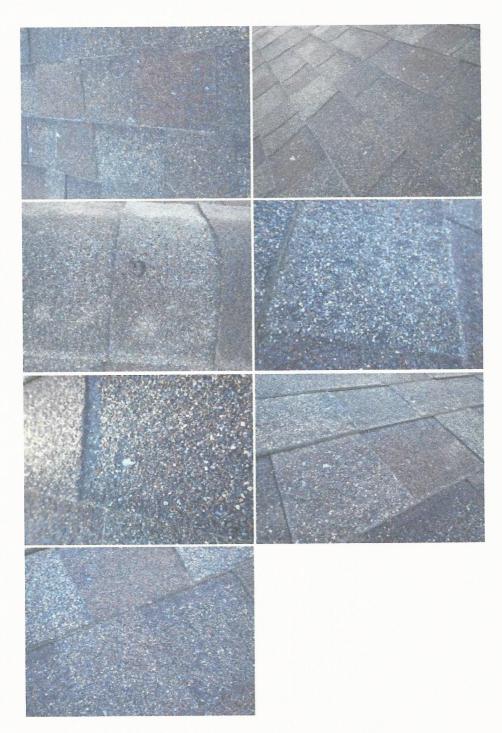
There is significant hail damage across this roof. This roof needs to be replaced.

0 years. This roof is shot and needs to be replaced.

Recommend having a licensed Roofing Contractor replace as deemed necessary.
