Inspection: [REDACTED] Address: [REDACTED]

Electrical System

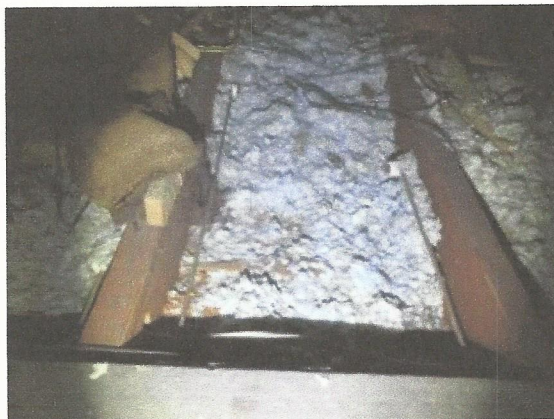
Attic Wiring:

Live knob-n-tube wiring is present. This old, out-of-date wiring can be a fire hazard. It needs 3" clearance so it doesn't overheat. Over time, the frail sheathing can become damaged or chewed exposing the live wiring. It is designed for only 15 amps and for the original wiring schematics of the home. This wiring shouldn't be added onto or spliced into as it can overload it. We recommend that this wiring be removed and replaced with Romex by a licensed Electrician as they deem necessary.

Recommend having a licensed Electrician review and correct as deemed necessary.
