Inspection: [REDACTED] Address: [REDACTED]

Roof System

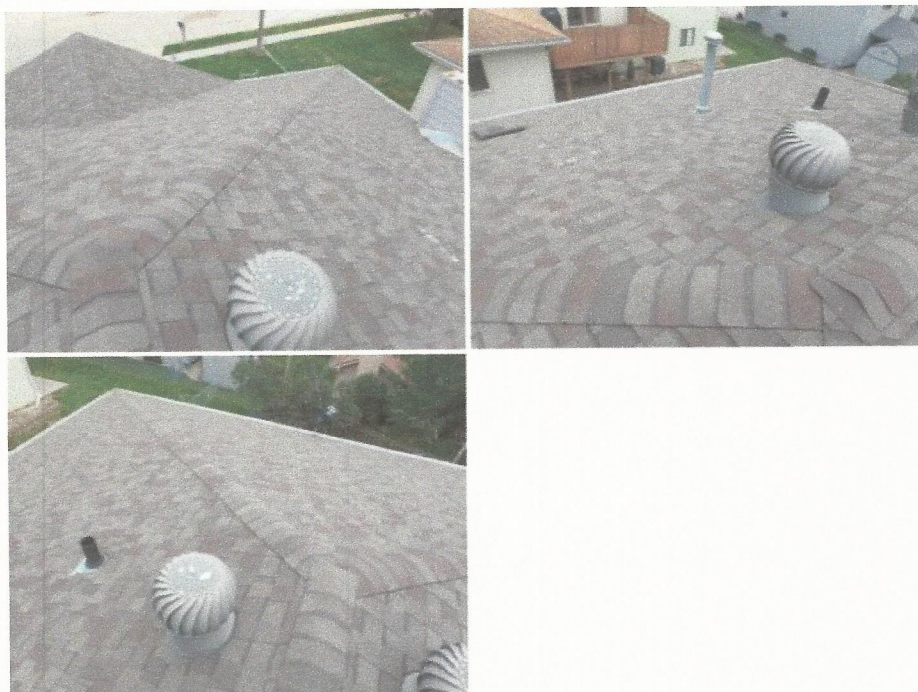
Hip. (Different views of the roof.)

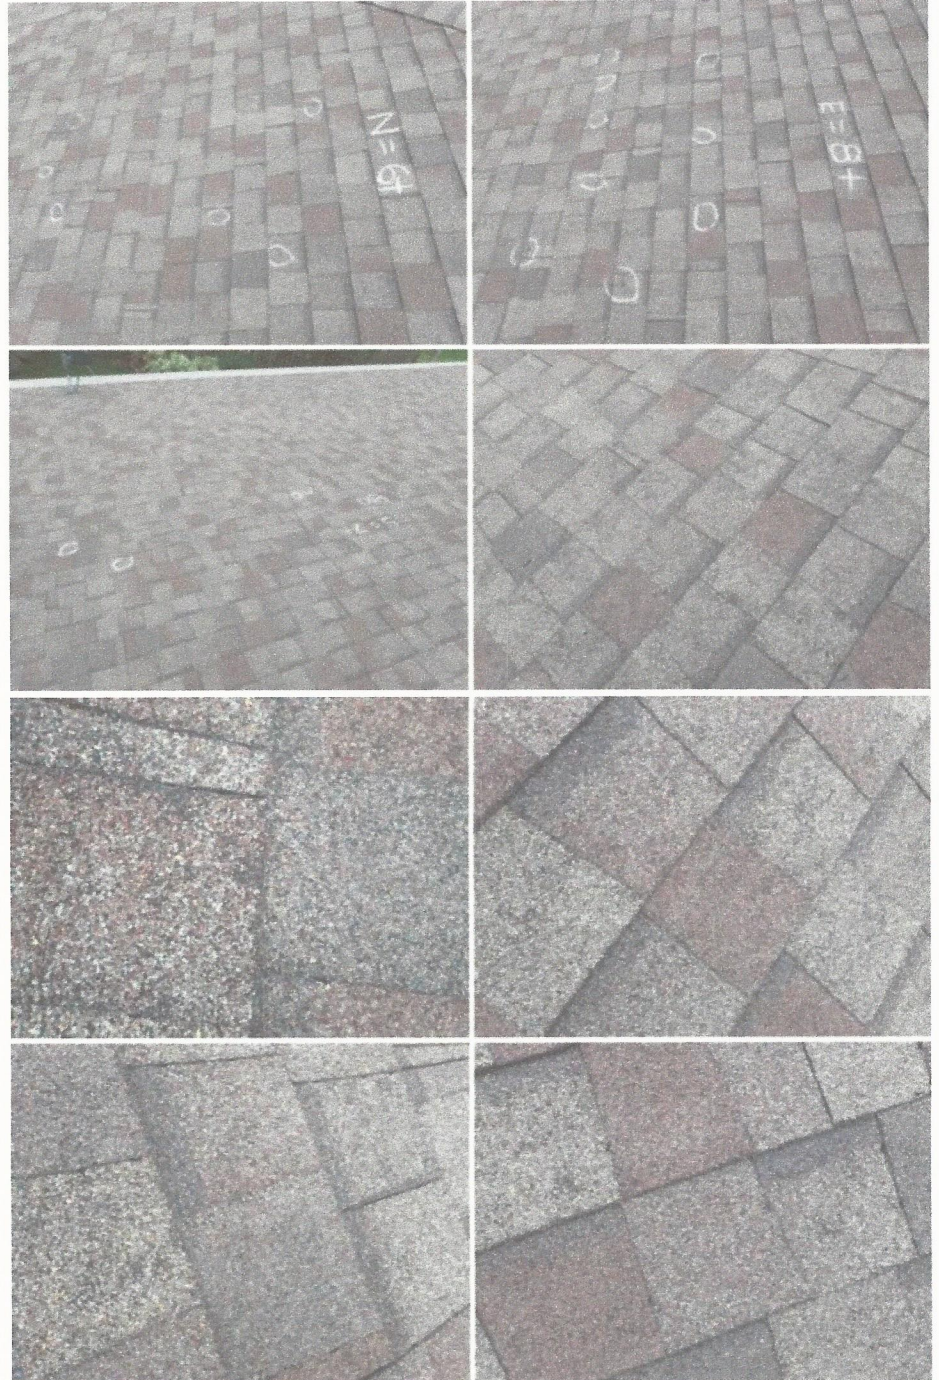
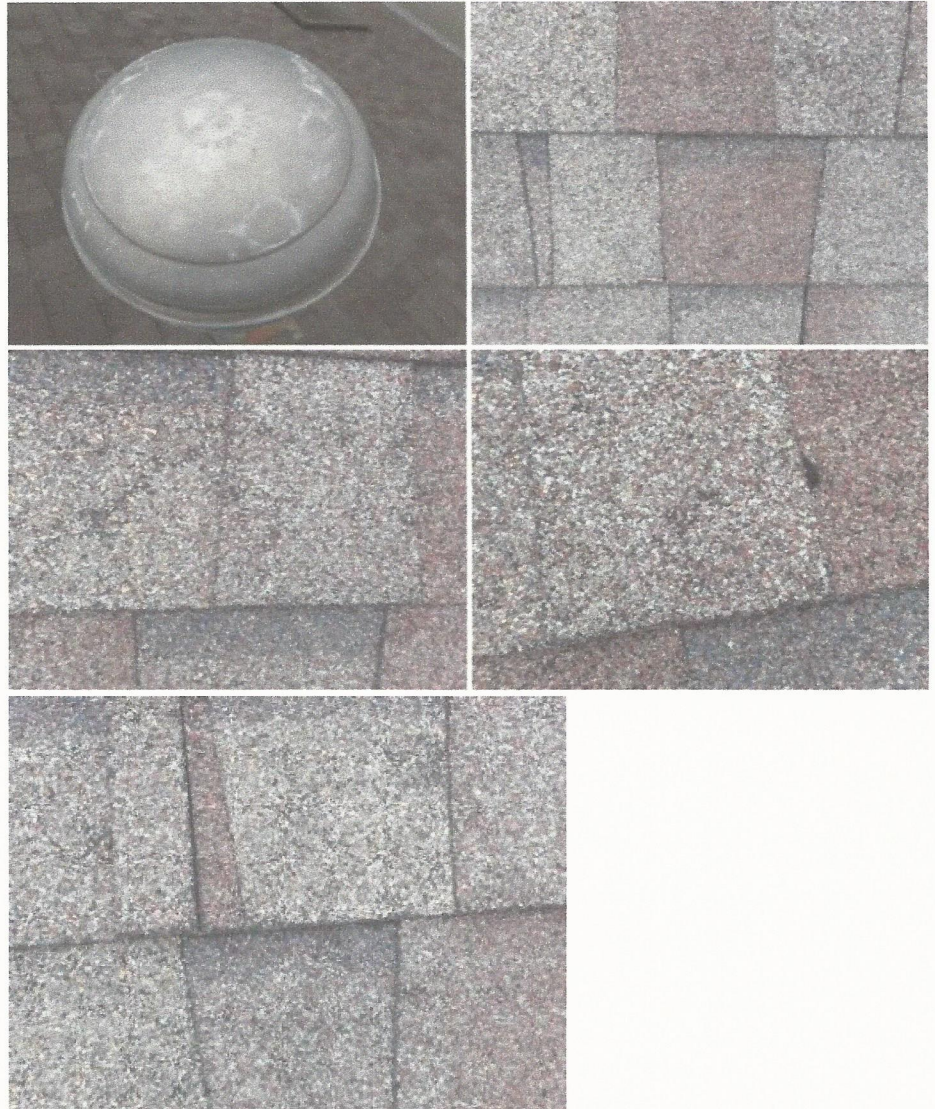
There is significant hail damage across the entire roof. This roof needs to be replaced.

Estimated Remaining Useful Life: 0 years. This roof is shot and needs to be replaced.

Recommendation(s): Recommend having a licensed Roofing Contractor replace as deemed necessary.
